Concrete slab strengthened with FRP composites: strains & cracks

Nerve-Sensors: Case Study

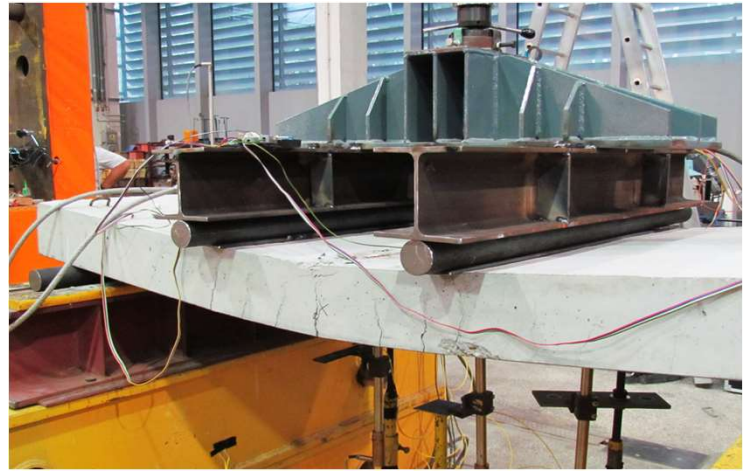
The reinforced concrete slabs were investigated in laboratory conditions in mechanical four point bending tests. Some were strengthened with FRP material to analyse this solution's effectiveness. However, the application of FRP prevented visual inspection of cracks. That is why all the slabs were equipped with distributed optical fibre strain sensors placed in-between the concrete and the strengthening material, which allowed for the detection of all cracks invisible to the naked eye.

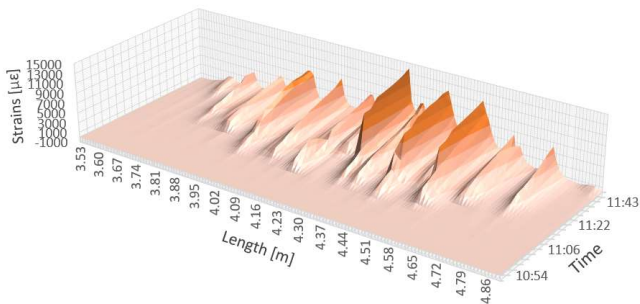
Example results

One of the research goals was to compare structural behaviour (including crack morphology) of concrete slabs with and without FRP strengthening. DFOS strain sensors installed within the structural connection allowed to complete this task successfully. The figure below shows the example strain profile and corresponding cracks detected during mechanical bending tests.
