Concrete slab strengthened with FRP composites: strains & cracks

Nerve-Sensors: Case Study

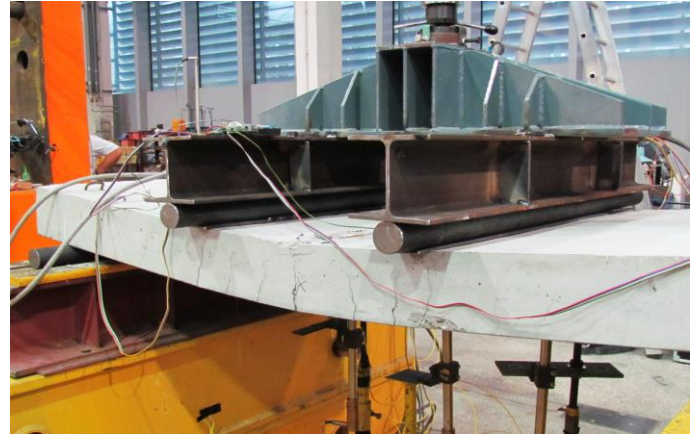
The reinforced concrete slabs were investigated in laboratory conditions in mechanical four point bending tests. Some of them were strengthened with FRP material to analyze the effectiveness of such solution. However, the application of FRP prevented visual inspection of cracks. That is why all the slabs were equipped with distributed optical fibre strain sensors between the concrete and strengthening material, what allowed for detection of all the cracks invisible to the naked eye.

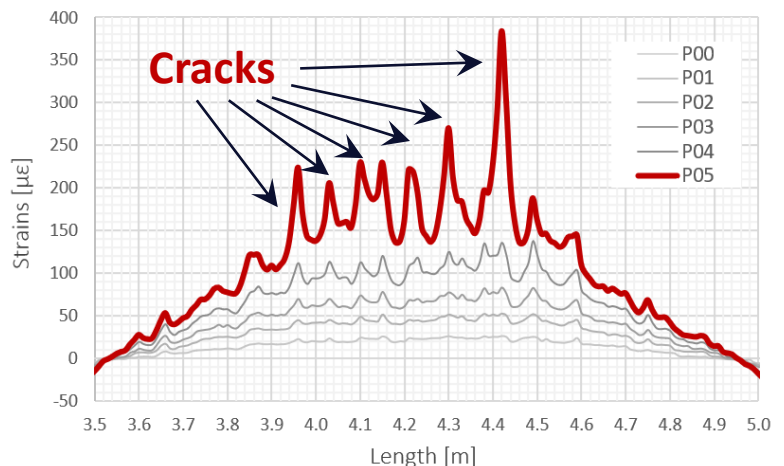
One of the research goals was to compare structural behaviour (including crack morphology) of concrete slabs with and without FRP strengthening. DFOS strain sensors installed within the structural connection allowed to complete this task successfully. The figure below shows the example strain profile and corresponding crack detected during mechanical bending tests.
