# Concrete column-slab system: simulation of column failure

## EpsilonSensor: Case Study

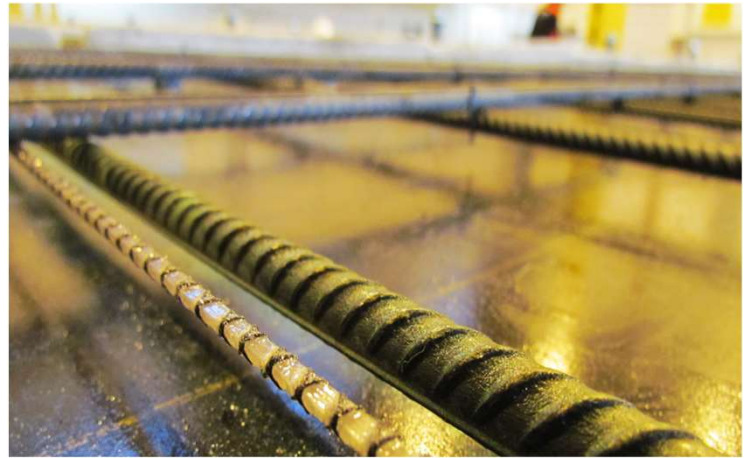
The performance of a full-scale concrete structure was investigated during the simulation of column failure. EpsilonSensors were installed inside the slab by tightening to the existing reinforcement. The main aim was to observe the crack morphology. Additional optical fibres were glued to the steel reinforcement to analyse its behaviour during the yielding process. The Nerve-Sensor system measured strains successfully during the entire research until the planned structural failure.

EpsilonSensors allowed for detailed structural performance analysis during key research steps: (1) mechanical loading in the elastic range, (2) changing the static scheme by removing the column (see the first cracks in the figure) and (3) additional loading through hydraulic jacket up to the total structural failure. Max. registered strains were ten times higher than in the case of conventional foil strain gauges, which were destroyed very early on.
