Concrete column-slab system: simulation of column failure

EpsilonSensor: Case Study

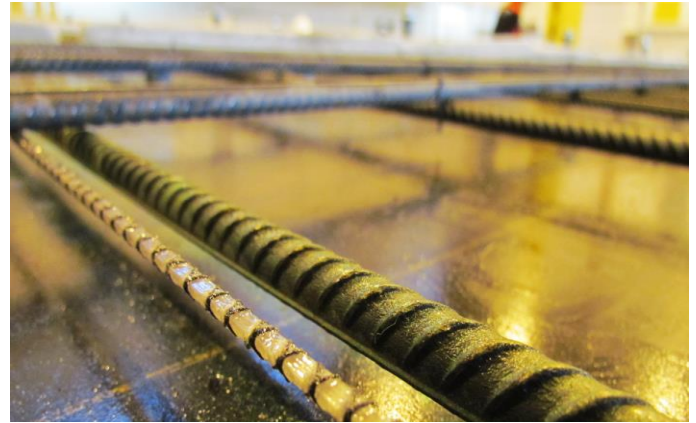
The performance of full-scale concrete structure was investigated during the simulation of column failure. **EpsilonSensors** were installed inside the slab by tightening to the existing reinforcement. The main aim was to observe the crack morphology. What is more, additional optical fibres were glued to the steel reinforcement to analyze its behaviour during yielding process. The **Nerve-Sensor** system was able to measure strains successfully during entire research up until the structural failure.

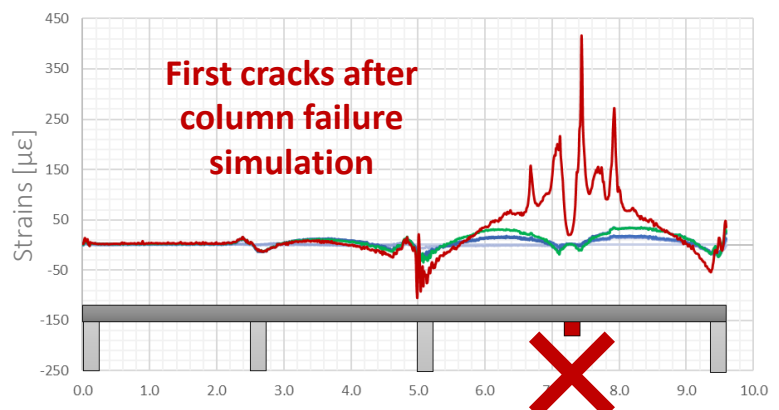
Example results

EpsilonSensors allowed for detailed structural performance analysis during few research steps: (1) mechanical loading in elastic range, (2) changing the static scheme by removing the column (see the first cracks in the figure) and (3) additional loading through hydraulic jacket up to the total structural failure. Max. registered strains were 10 times higher than in case of conventional foil strain gauges, which were destroyed very early.
