Steel-concrete railway bridge: strains and cracks during load tests

Nerve-Sensors: Case Study

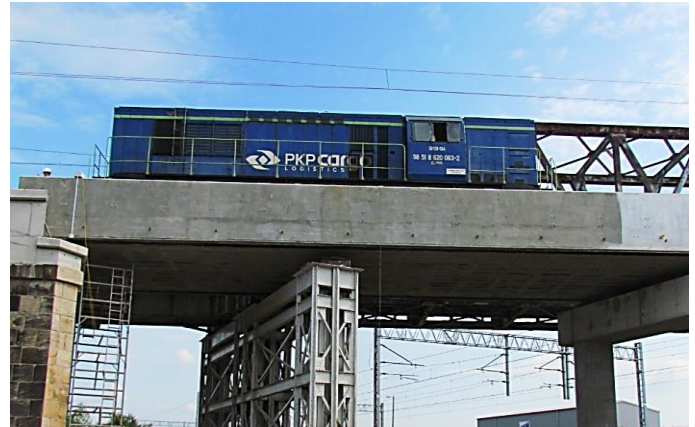
The composite (steel-concrete) bridge in Dąbrowa Górnicza was designed according new approach and put into the service in 2019. That is why verification of its structural performance under real operating conditions was of the significant importance. The bridge was equipped with DFOS strain sensors, installed both on the concrete and steel surfaces. The measurements during load tests allowed for detailed analysis of deformation state, including the detection of all microcracks.

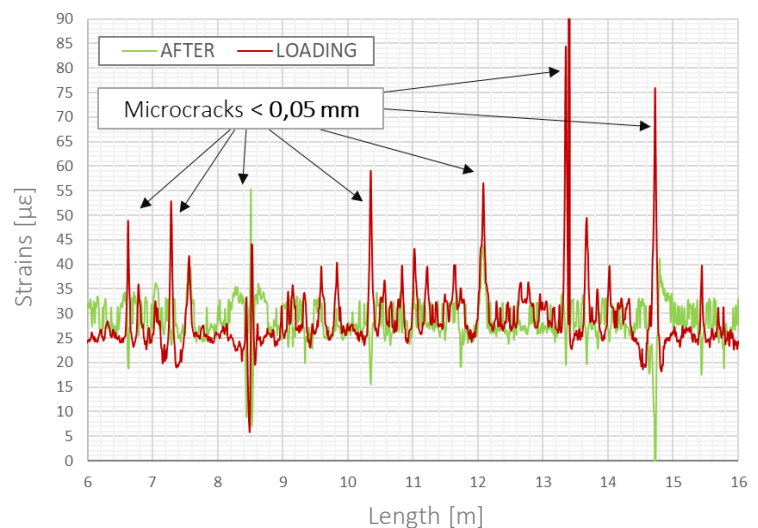
Distributed fibre optic strain sensors were installed at the bottom and top flange of the steel girder, as well as at the side surface of the concrete. Such sensing system allowed for detailed analysis of interaction between these two materials as well as for validation of new design approach. The distributed measurements during load tests (locomotive load) prior to commissioning enabled the detection of all microcracks along the girder length. However, most of them were closed after removing the load, what was a very important information for engineer responsible for the long term safety and durability of the bridge.
