Steel-concrete railway bridge: strains and cracks during load tests

Nerve-Sensors: Case Study

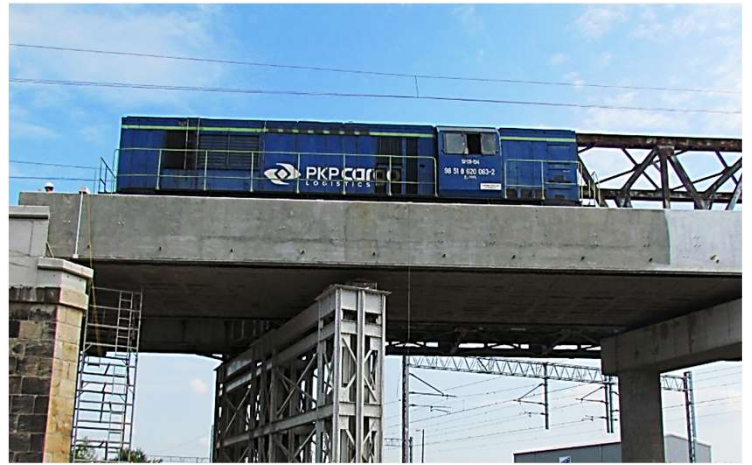
The composite (steel-concrete) bridge in Dąbrowa Górnica was designed according to a new approach and put into the service in 2019. This is why verification of its structural performance under real operating conditions was of significant importance. The bridge was equipped with DFOS strain sensors, installed both on the concrete and steel surfaces. The measurements during load tests allowed for detailed analysis of the deformation state, including the detection of all microcracks.

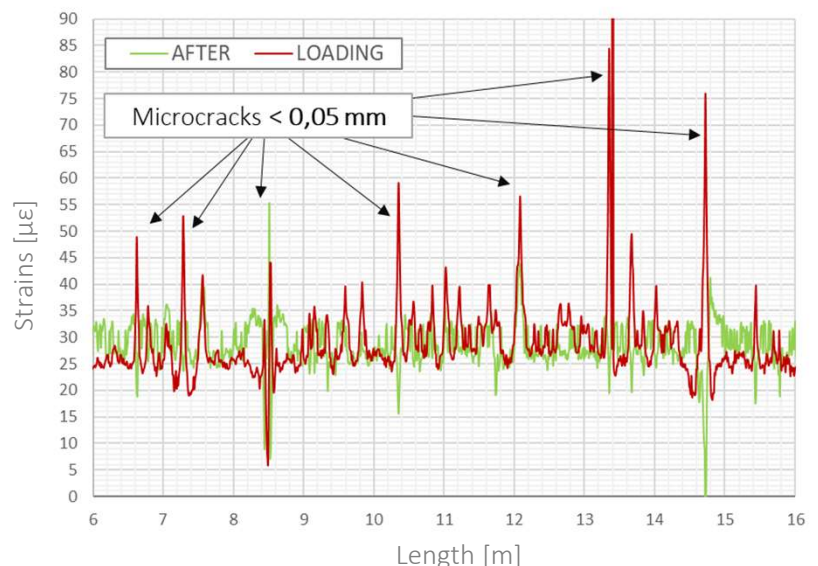
Distributed fibre optic strain sensors were installed at the bottom and top flange of the steel girder, as well as at the side surface of the concrete. Such a sensing system setup allowed for detailed analysis of the interaction between these two materials and validation of a new design approach. Distributed measurements taken during load tests (locomotive load) prior to commissioning enabled the detection of all microcracks along the girder length. However, most of them were closed after removing the load, which was very important information for the engineer responsible for the long-term safety and durability of the bridge.
