One of the largest concrete bridge in Poland – crack detection

EpsilonRebar: Case Study

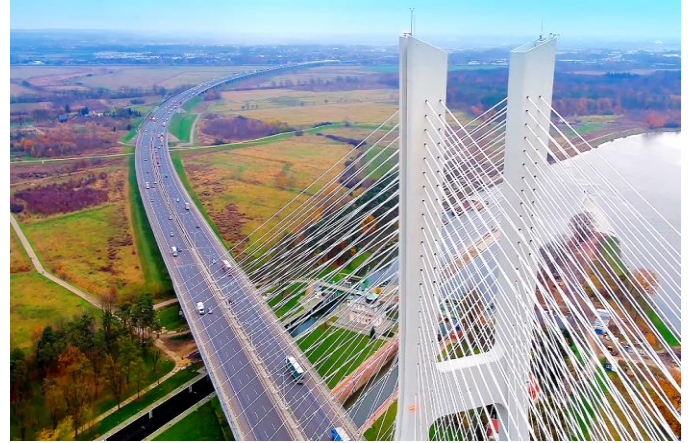
EpsilonRebars had been chosen for this project as the best solution dedicated to crack detection and estimation of their width changes. Four sensors were installed in the pylon's horizontal beam, supporting the deck slab. In this case, a near-to-surface installation method was applied (grooves) to provide appropriate integration of EpsilonRebars with the existing concrete and to create natural protection against the environmental impacts.

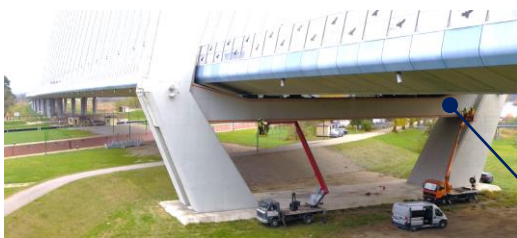
EpsilonRebars integrated with the bridge pylon allowed for detailed analysis of cracks' patterns along the supporting beam. It was also possible to observe real-time changes in widths, despite being extremely small – see example data in the plot below. Analysis of such tiny events was possible only thanks to the appropriate mechanical properties of the **Nerve-Sensors** and their perfect bonding with the surrounding concrete.
