Historical post-tensioned bridge over Motława river

EpsilonSensor: Case Study

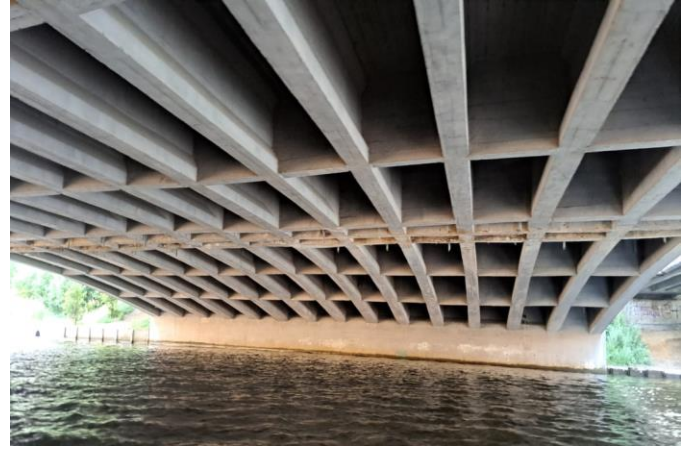
The historical bridge in question was built in the late 1950s last century. After more than 60 years of operation, the question of the further maintenance and safety of the facility had to be answered. Four EpsilonSensors were installed within the safety-critical areas, i.e. at concrete cantilevers next to the construction joints, to support engineers in optimal decision-making. The near-to-surface installation inside the groove was applied as the best solution for existing concrete structures.

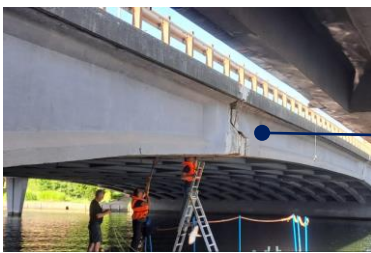
Example results

The main aim of the research was to investigate the real-time structural response of post-tensioned concrete cantilever to the actual traffic load, including cars and heavy trucks. High-frequency measurements confirmed the lack of active cracks and allowed a detailed analysis of the strain-stress state. All data will be used to support the expert in assessing of technical condition of this historic bridge.
