Anchorage zone in 57-year-old post-tensioned precast girder

Nerve-Sensors: Case Study

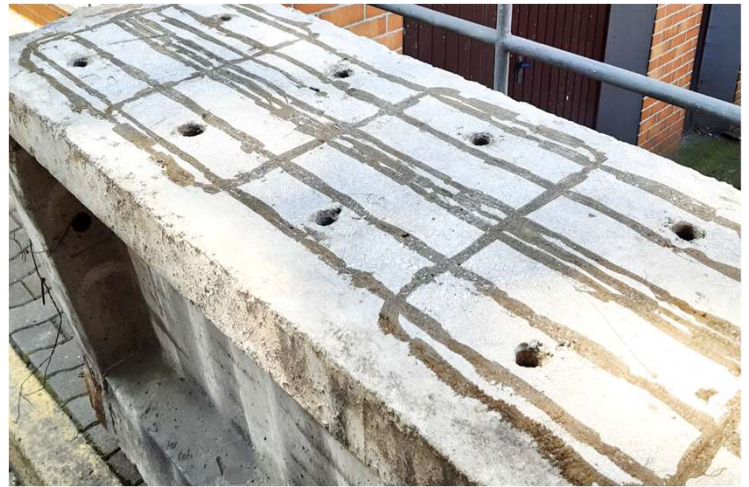
DFOS sensors were glued to the upper surface of the girder using two-component epoxy to monitor strains within the anchorage zone (along longitudinal and transverse sections at the same time). Thanks to high-spatial-resolution strain measurements, and the transmission length of the tendon related to the quality of cement injection was analysed in a very detailed way. The measurements were performed in both static and dynamic (high-frequency) ways while cutting one of the tendons off. Moreover, detection of existing microcracks and estimation of their widths was possible. The performed tests proved the great possibilities of DFOS technology for evaluating existing prestressed-concrete structures.
