# Industrial tower in the largest mining tailings reservoir in Europe

## 3DSensor: Case Study

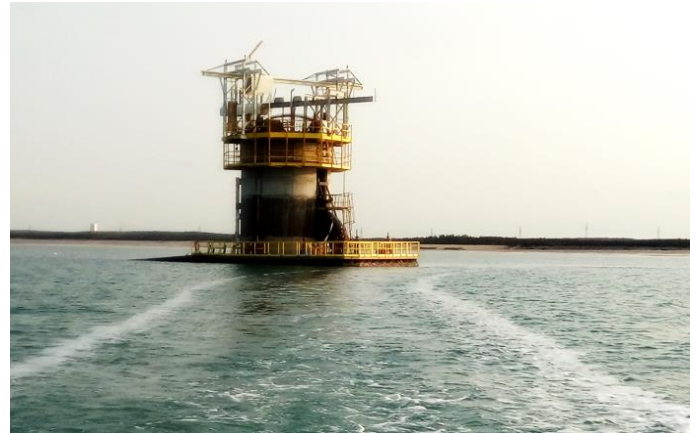
Żelazny Most Reservoir is the largest reservoir for copper mining tailings in Europe, owned by KGHM Polska Miedź. It was put into exploitation on February 12, 1977. There are 4 industrial overflow towers on the site. One of them in 2018 was equipped with vertical 3DSensors to monitor temperatures and horizontal displacements. One of the reasons for DFOS-based monitoring system installation were construction works to build the tower's new floors.

Seven segments of 3DSensor were delivered on site and installed on the walls of the tower's individual storeys, along its entire depth. Segments were connected together through the floors to create continuous sensing line. The measurements were performed during entire year to analyze the influence of significant temperature changes. This reliable system working in harsh, aggressive environmental conditions allowed the horizontal displacements of the tower to be measured with extremely high spatial resolution.
